The East-West Dry Stone Wall at 40 Dwyer Street Kalkallo Heritage

Archival Documentation and Conservation Management Plan

Authors: Brendan Marshall and Helene Athanasiadis

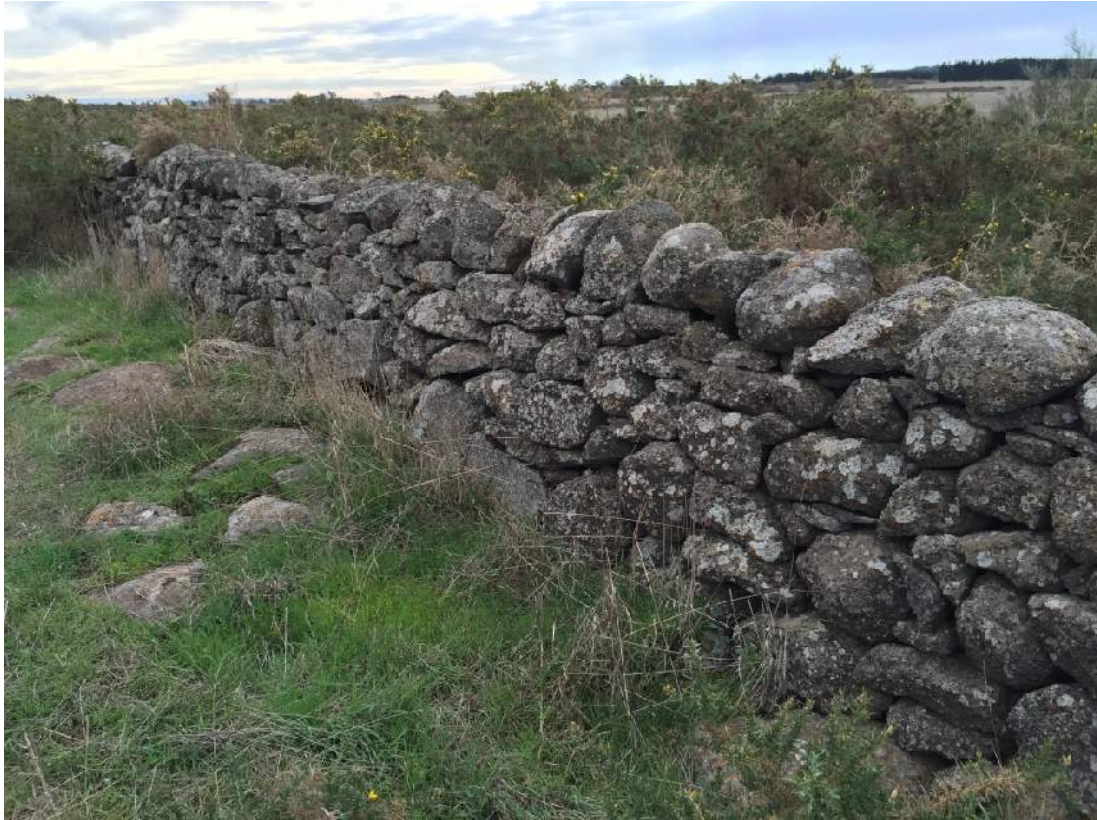
Plate 1. Section 1 of the east-west dry stone wall at 40 Dwyer Street Kalkallo. This is a well preserved part of the wall as the coping and plugging stones are in place. The stony rise is visible as rocks *in situ* in the ground (27/5/15 Photo R.J. Marshall).

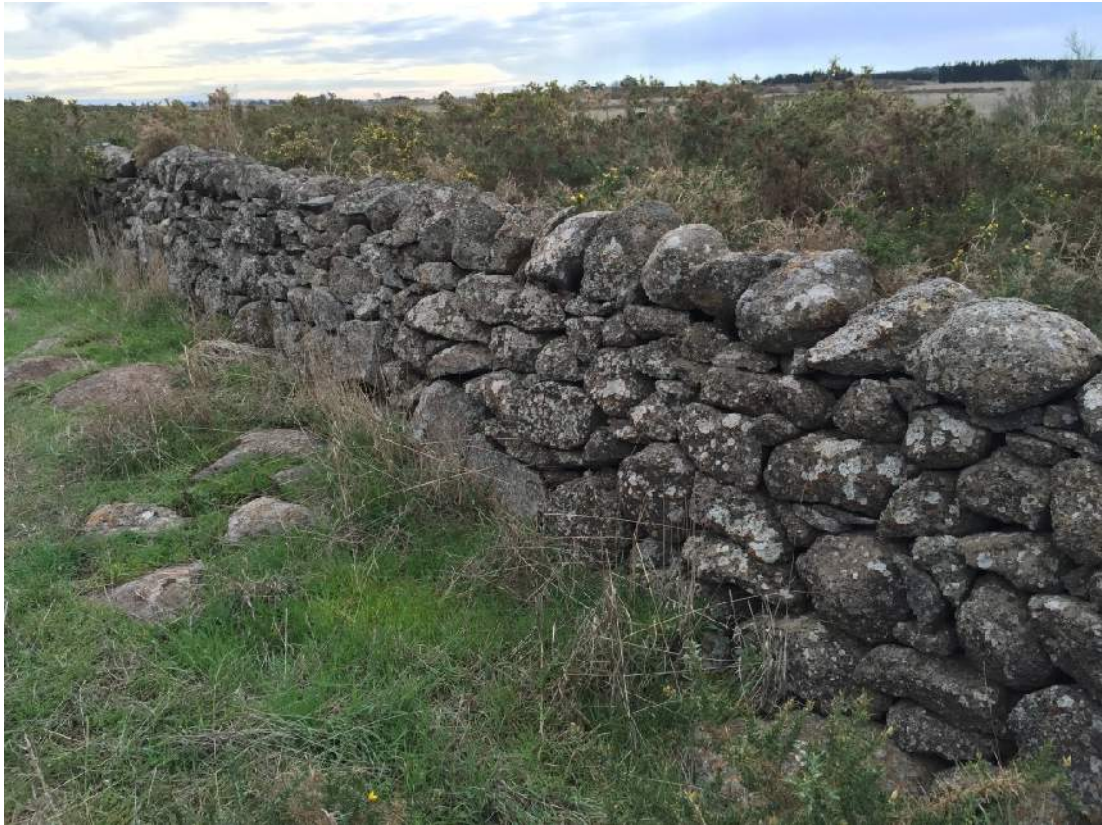
Plate 1. Section 1 of the east-west dry stone wall at 40 Dwyer Street Kalkallo. This is a well preserved part of the wall as the coping and plugging stones are in place. The stony rise is visible as rocks *in situ* in the ground (27/5/15 Photo R.J. Marshall).

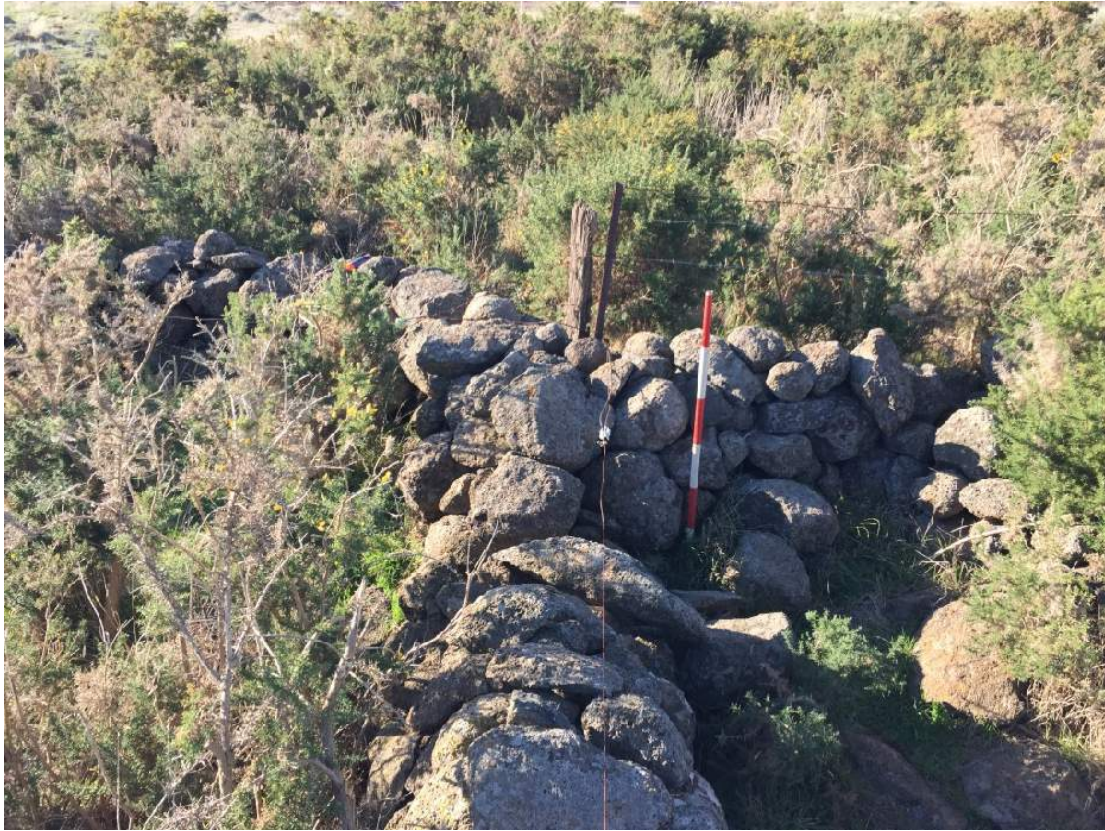
Plate 2. Intersection of wall Sections 1 and 2 of the east-west dry stone wall at 40 Dwyer Street Kalkallo. At this intersection the east-west wall heads north. The wall on the RHS of the frame is the northern end of a north-south dry stone wall which is a composite wall. A remnant timber post is visible in the middle frame (27/5/15 Photo R.J. Marshall).

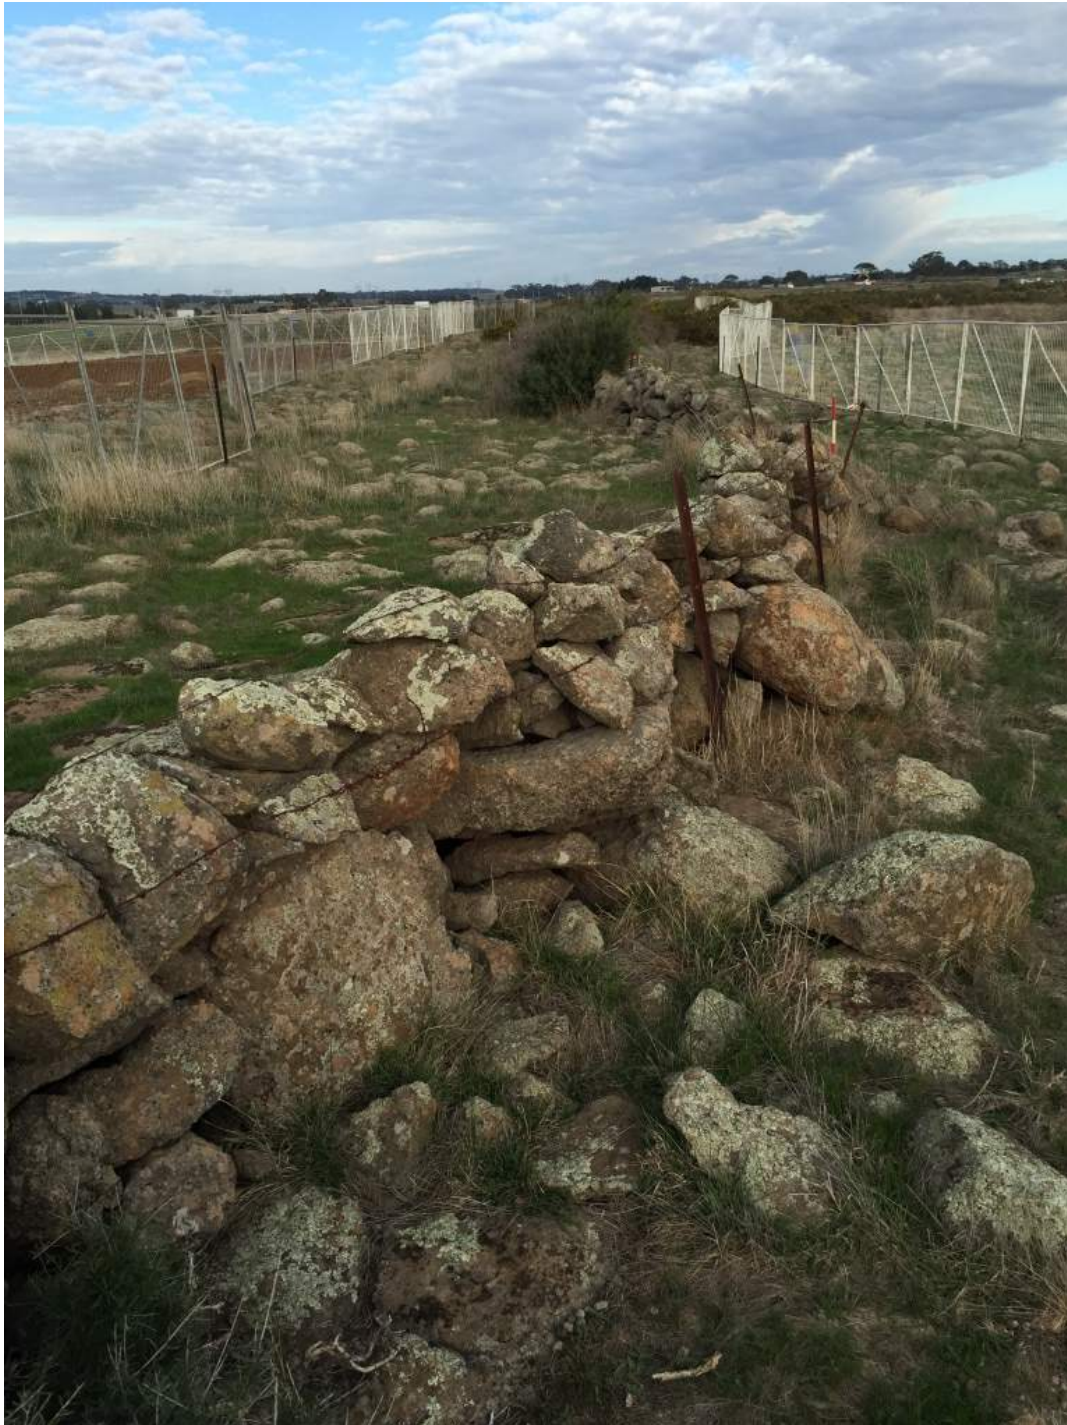
Plate 3. Wall 2 of the east-west dry stone wall at 40 Dwyer Street Kalkallo. This photo is looking in a southwesterly direction along the wall which has been protected from the nearby construction with some temporary fencing. Note the tumble of rocks in the foreground and the star picket and barb wire fence along its northern side indicating that whilst still a rural property the wall was no longer stockproof (27/5/15 Photo R.J. Marshall).

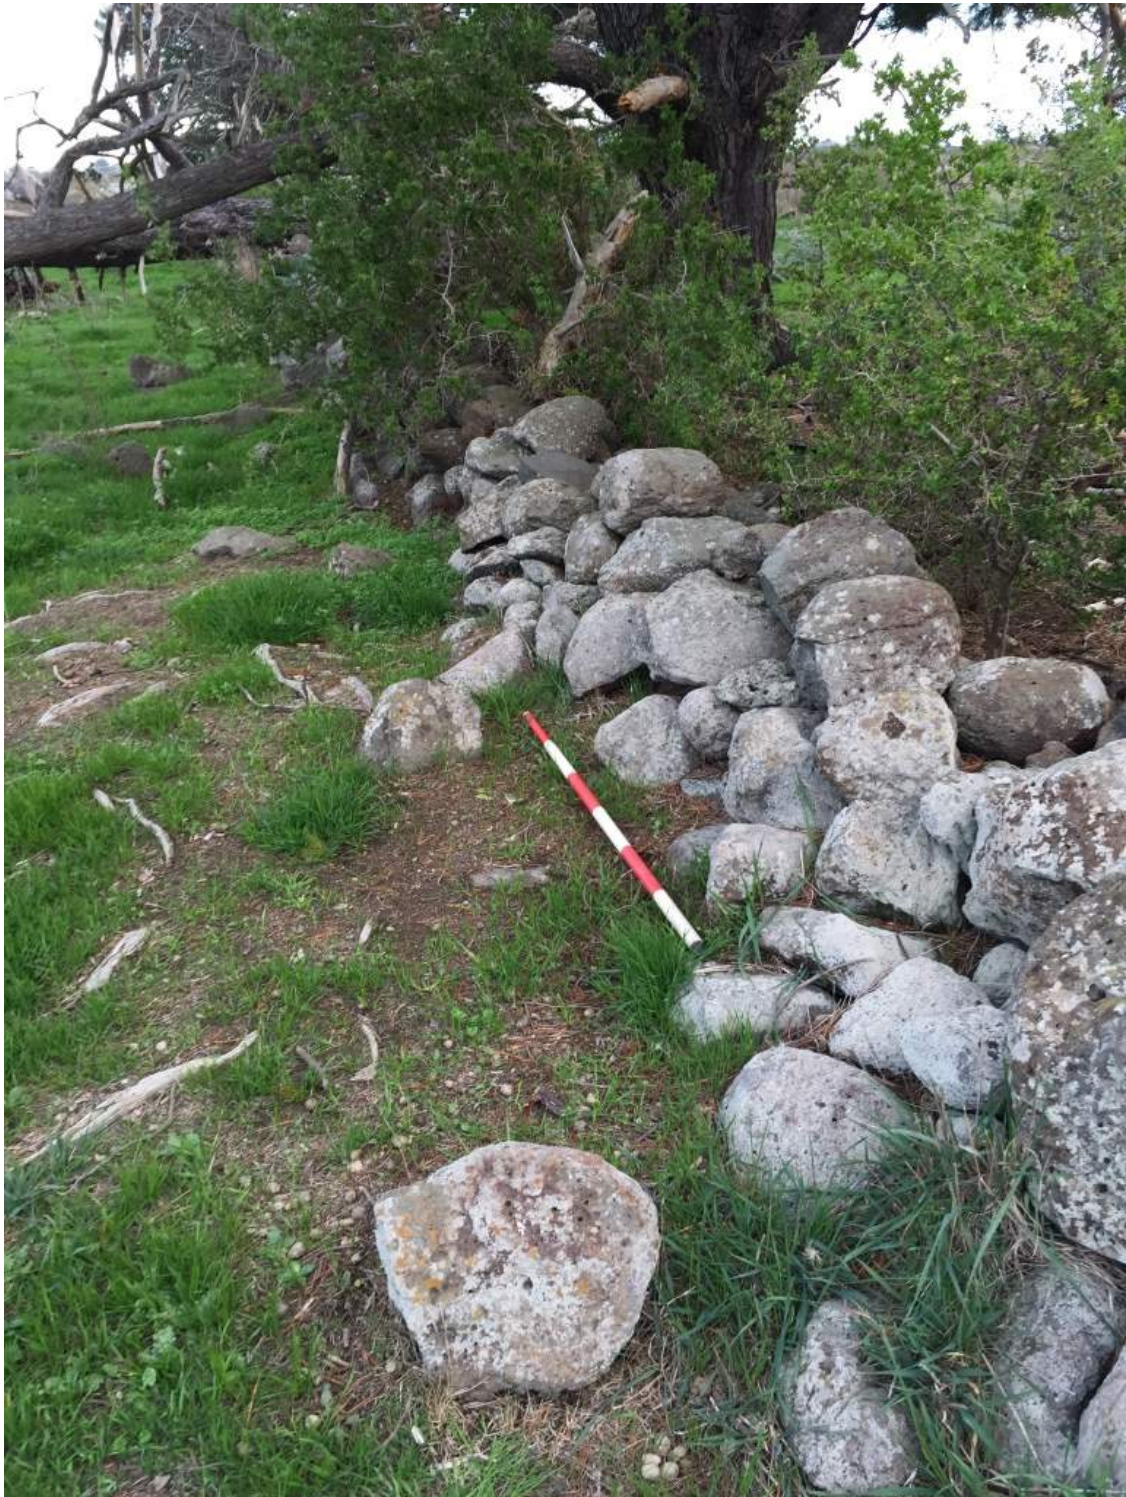
Plate 4. A section of Wall 3 of the east-west dry stone wall at 40 Dwyer Street Kalkallo. This is a poorly preserved part of the wall close to the Merri Creek floodplain and is a combination of aligned and tumbled rocks (27/5/15 Photo R.J. Marshall).

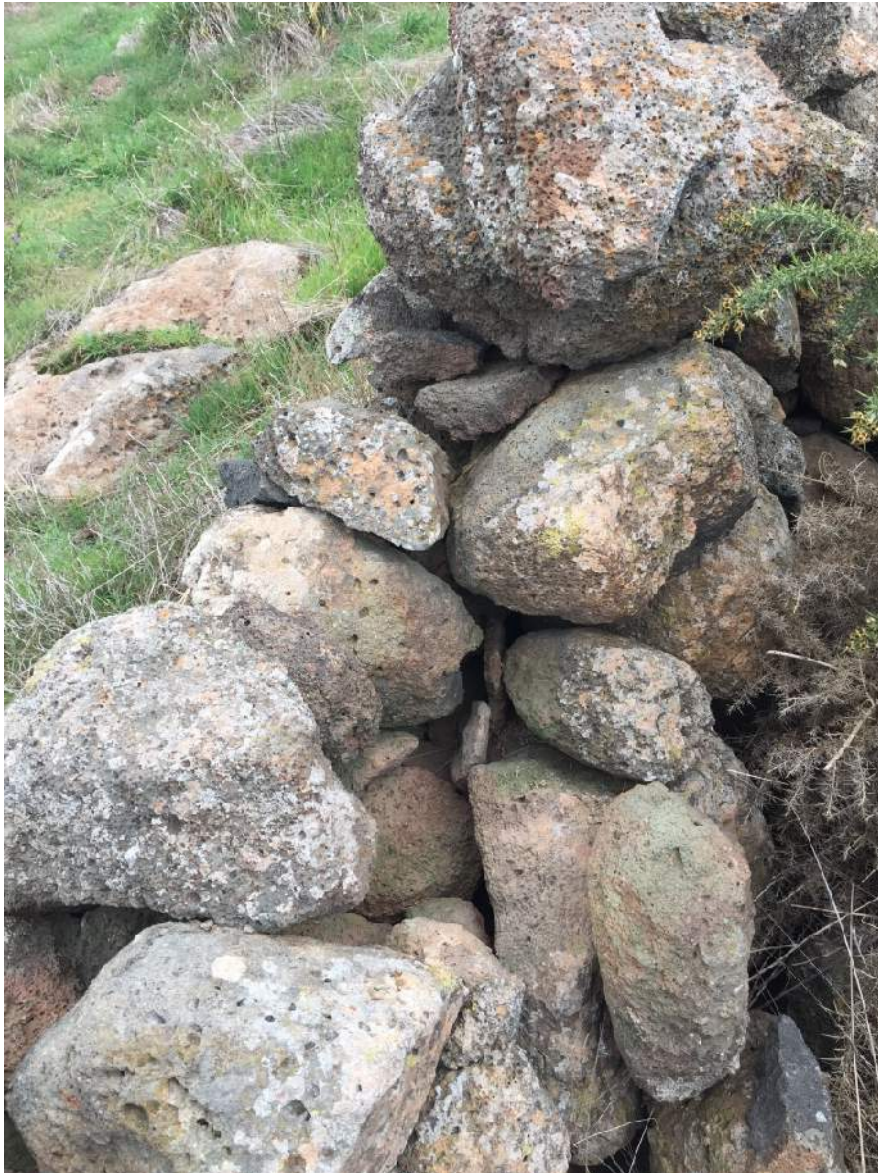
Collapse section of Section 1 of the east-west dry stone wall at 40 Dwyer Street Kalkallo showing infilling (27/5/15 Photo R.J. Marshall).

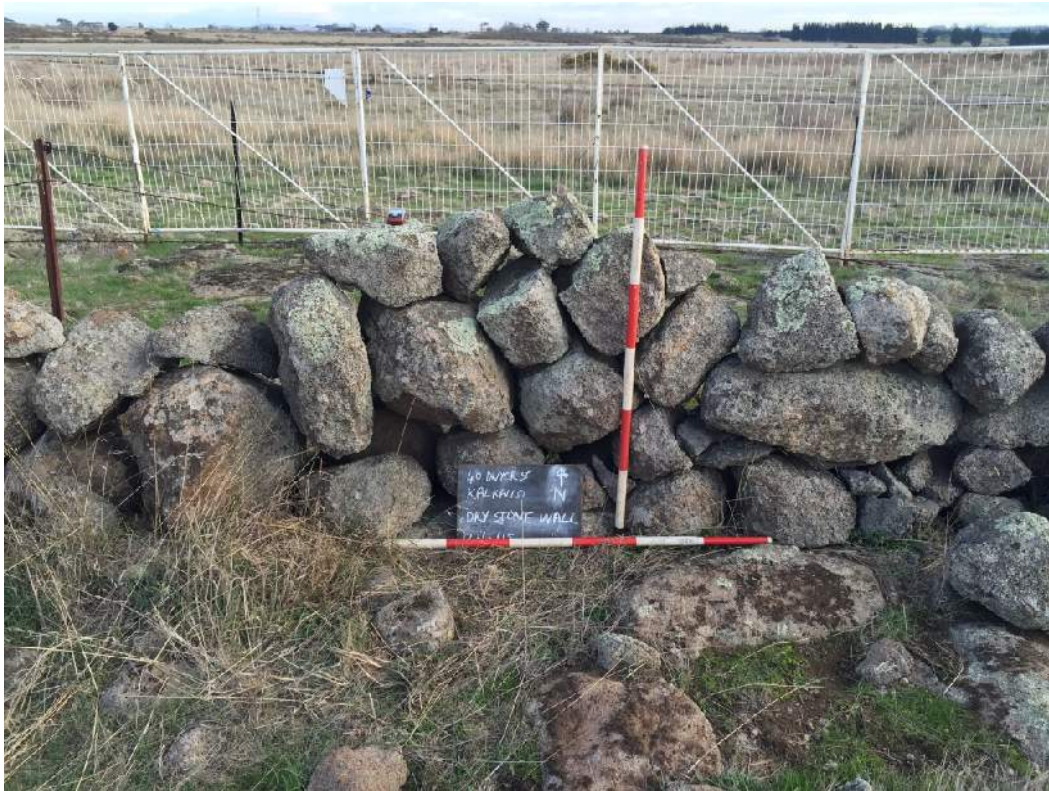
Midsection of Wall No 2 at 40 Dwyer Street Kalkallo which is partly collapsed looking south (27/5/15 Photo R.J. Marshall)

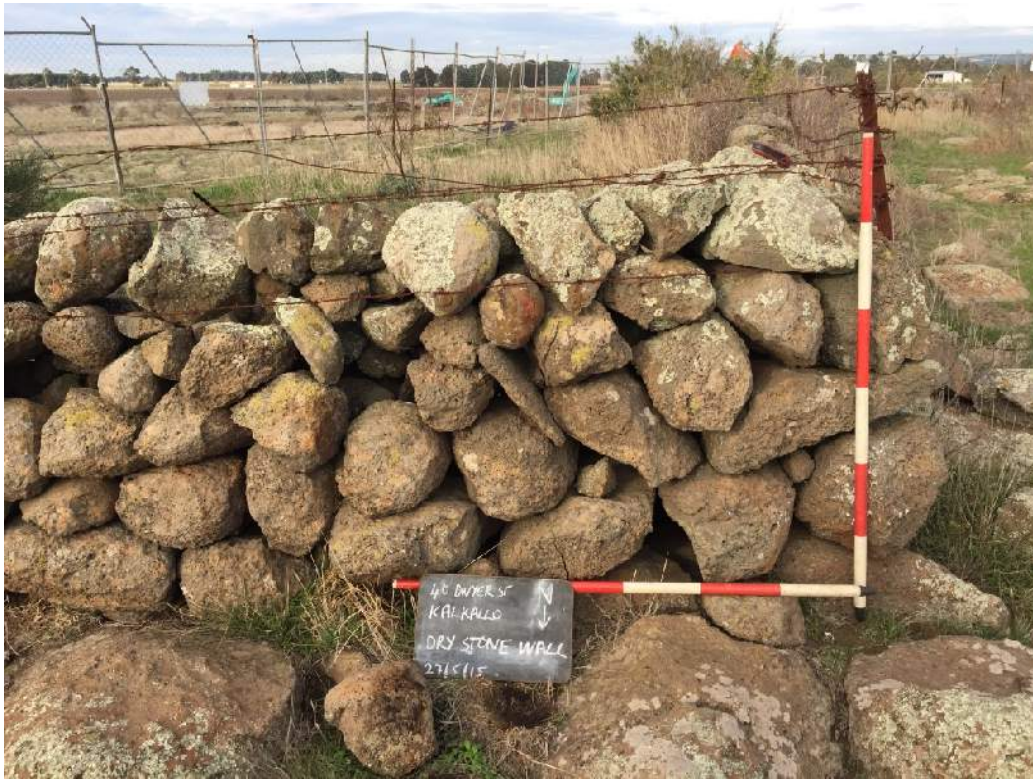
Wall 3 at 40 Dwyer Street Kalkallo its western end where it heads south to join wall No 2. Note the rough construction and the addition of the wire and star pickets (27/5/15 Photo R.J. Marshall).

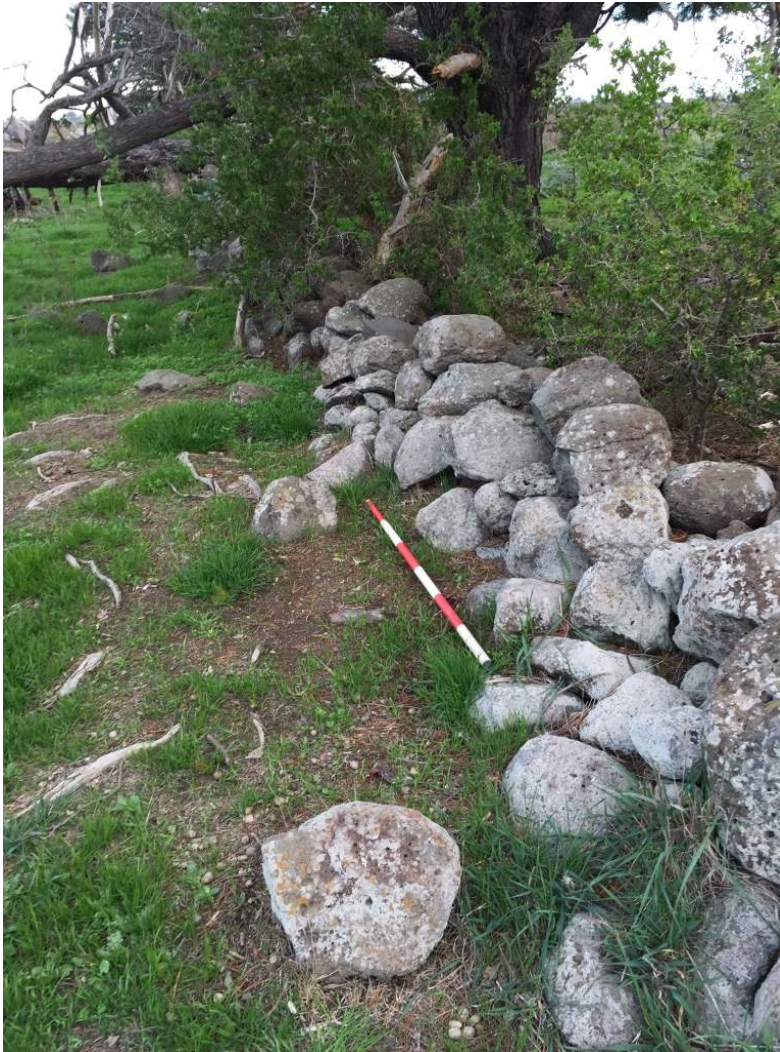
Partially collapsed section of Wall No 3 at 40 Dwyer Street Kalkallo near its eastern end looking along the alignment (27/5/15 Photo R.J. Marshall).

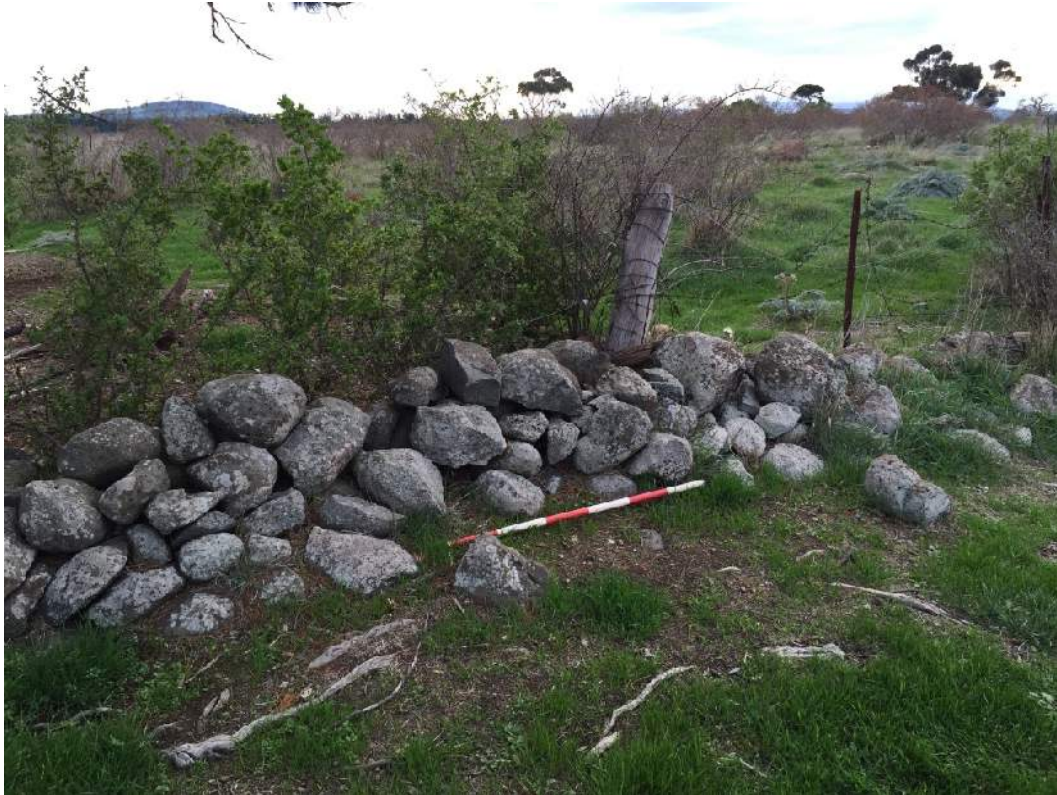
Wall 3 of the east-west dry stone wall at 40 Dwyer Street Kalkallo. This is a collapse section of a former composite wall. Note the corner timber post and recent wire and star picket additions. (27/5/15 Photo R.J. Marshall).
