The East-West Dry Stone Wall at 40 Dwyer Street Kalkallo Heritage

Archival Documentation and Conservation Management Plan

Authors: Brendan Marshall and Helene Athanasiadis

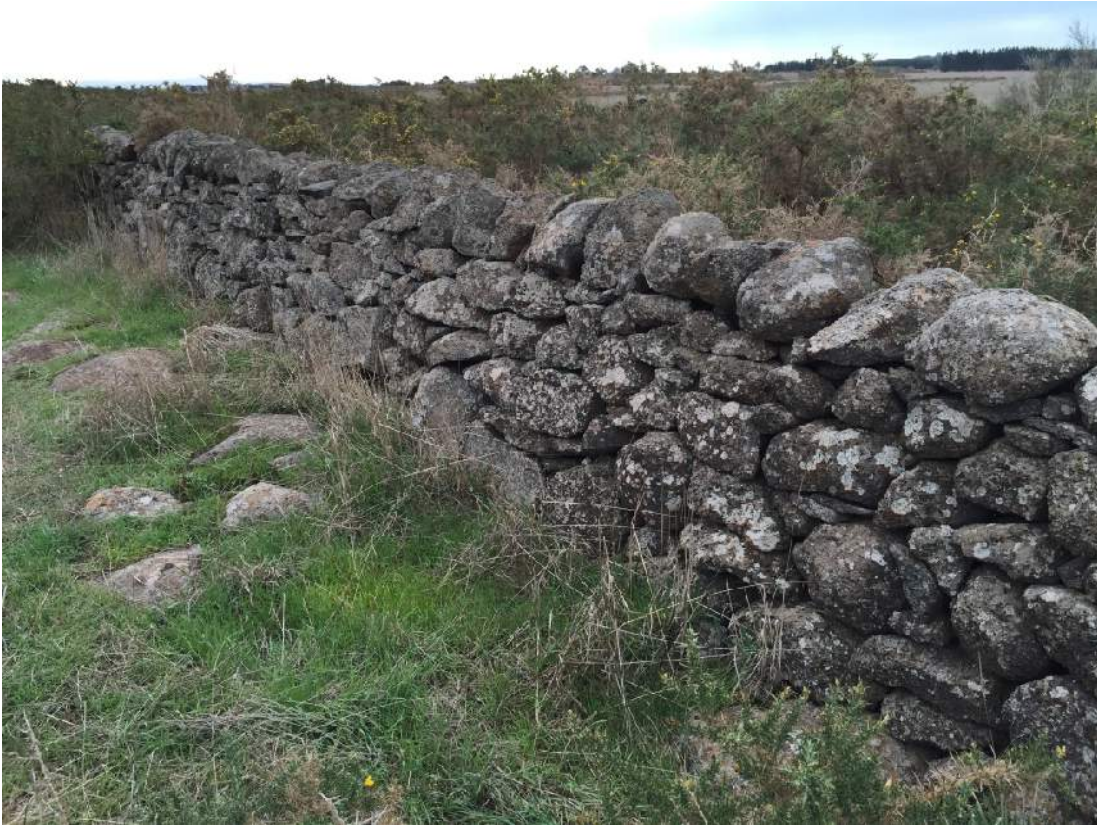
Section 1 of the east-west dry stone wall at 40 Dwyer Street Kalkallo. This is an intact section of the wall on its southern side (27/5/15 Photo R.J. Marshall).

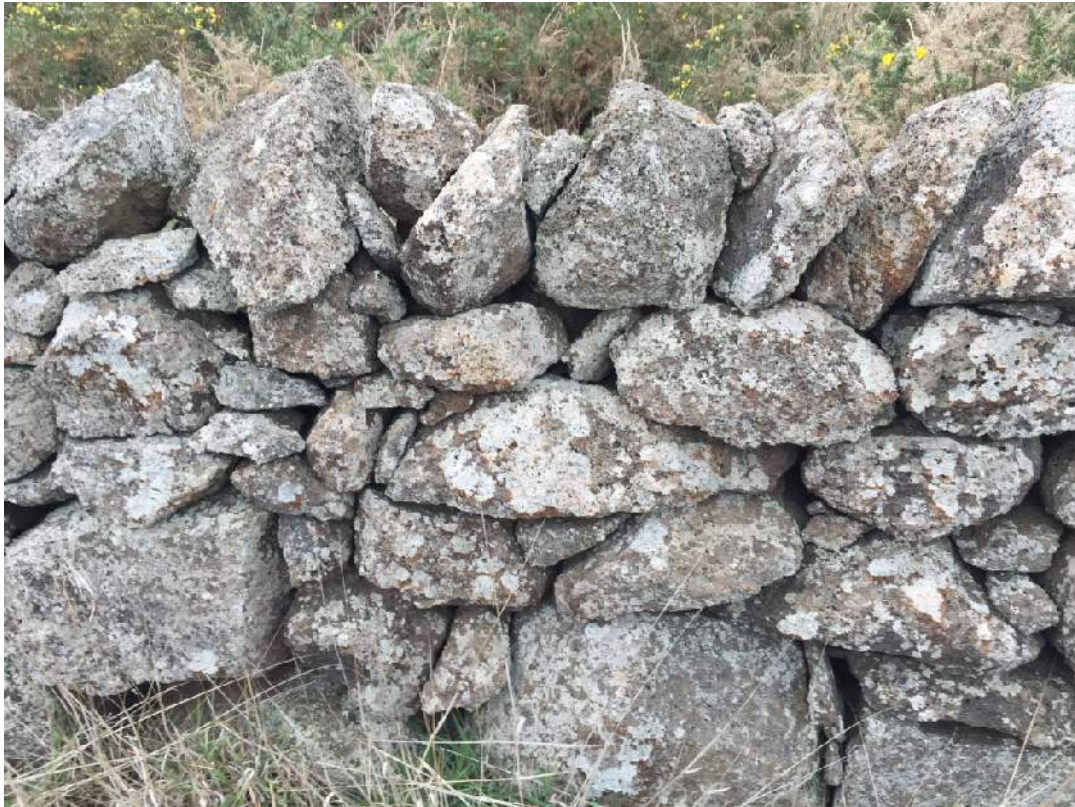
Section 1 of the east-west dry stone wall at 40 Dwyer Street Kalkallo. This is a detail showing the coping stones and plugging (27/5/15 Photo R.J. Marshall).

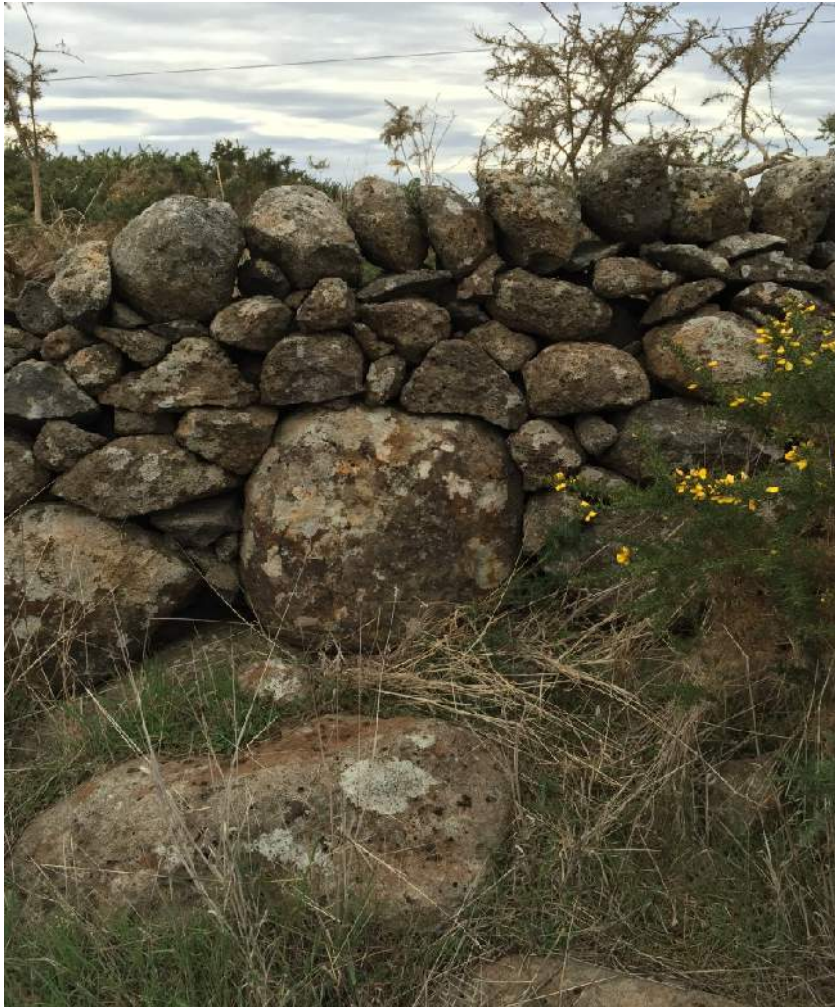
Section 1 of the east-west dry stone wall at 40 Dwyer Street Kalkallo showing the contact between the foundation stones and the underlying stony rise (27/5/15 Photo R.J. Marshall).

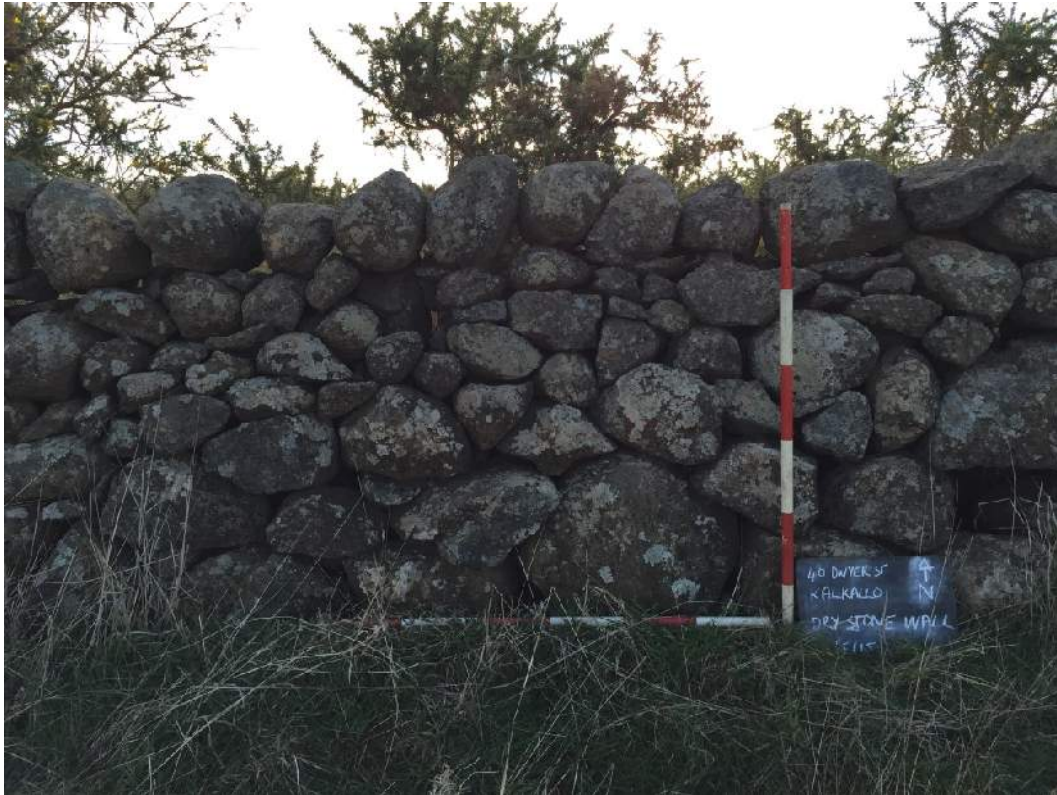
Section 1 of the east-west dry stone wall at 40 Dwyer Street Kalkallo showing detail of the coursing. Note the larger size coping stones over courses of smaller stone (27/5/15 Photo R.J. Marshall).

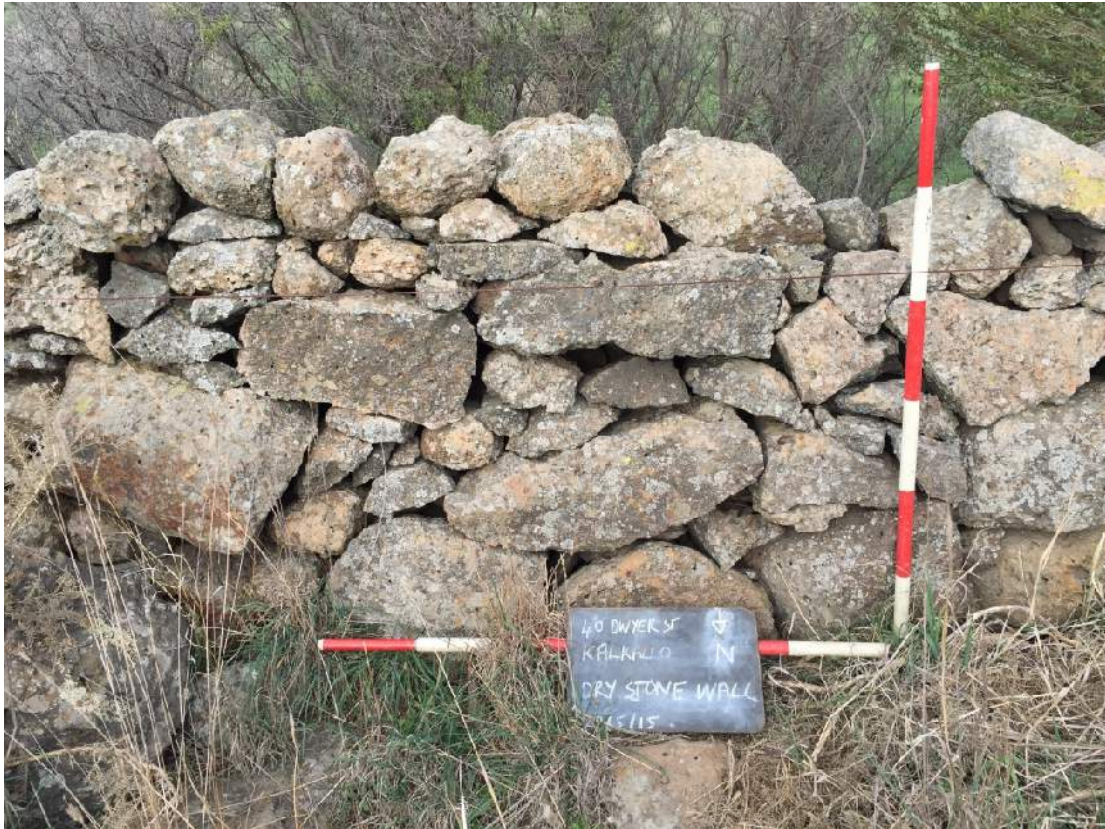
Section 1 of the east-west dry stone wall at 40 Dwyer Street Kalkallo showing detail of stones (middle frame) that have been altered, possibly faced (27/5/15 Photo R.J. Marshall).

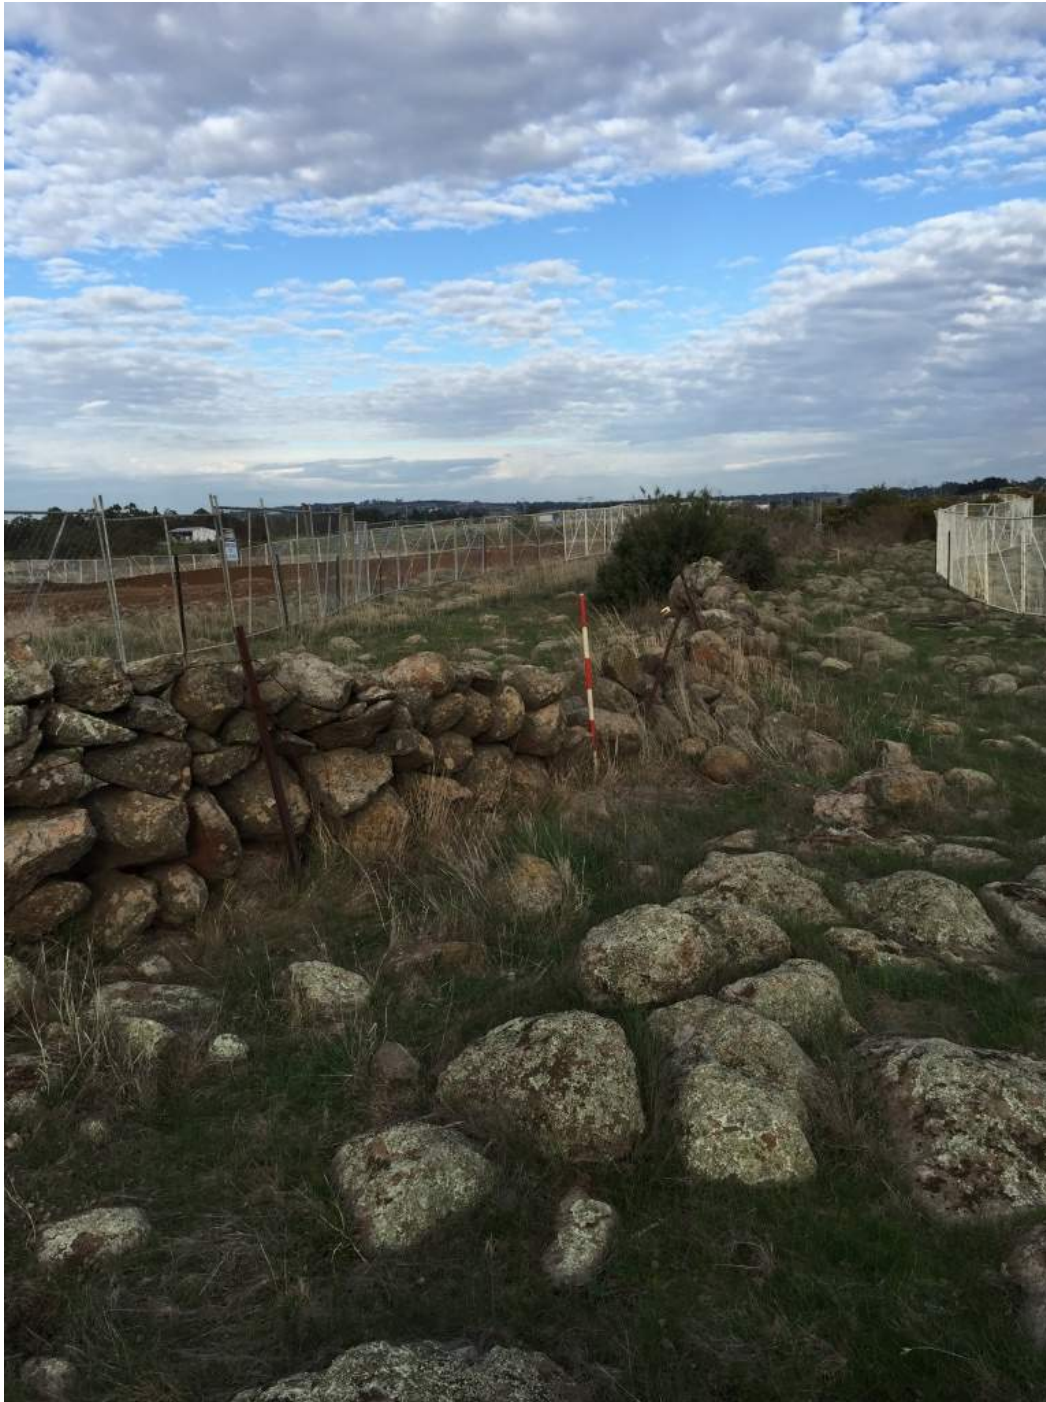
Wall No 2 at 40 Dwyer Street Kalkallo looking along its alignment in a south-westerly direction. The *in situ* floaters of the stony rise are visible in the foreground (27/5/15 Photo R.J. Marshall).

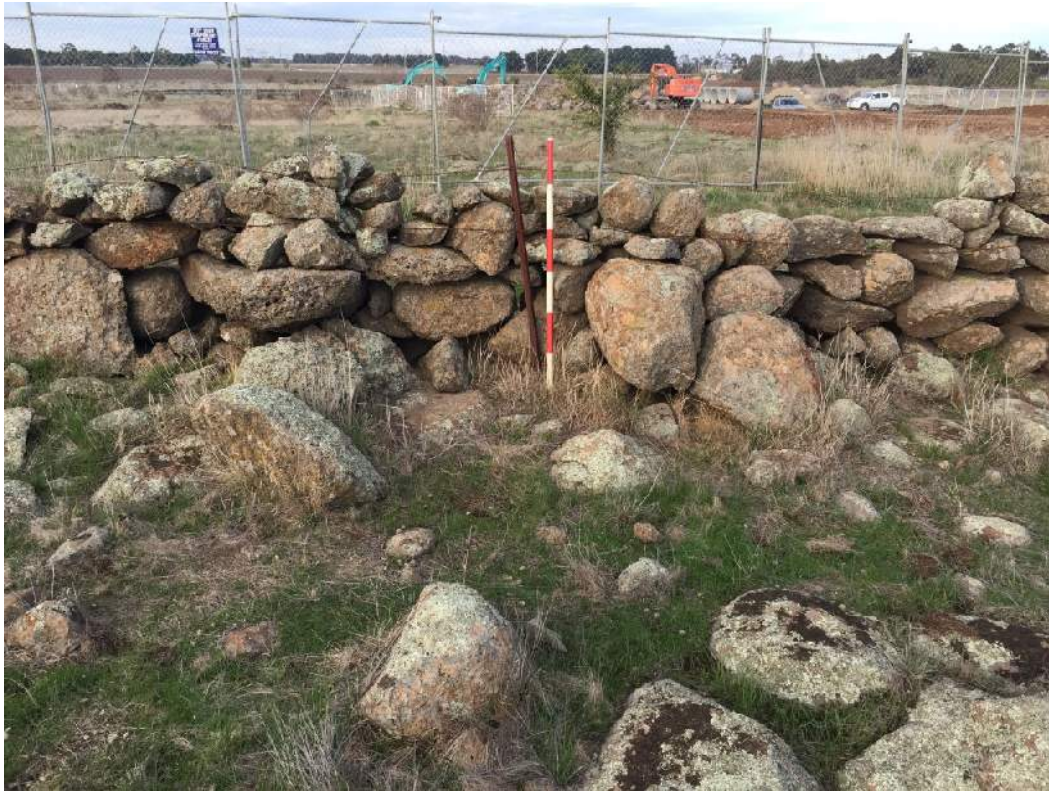
Midsection of Wall No 2 at 40 Dwyer Street Kalkallo looking south. There is a notable size variation in the stone along this section (27/5/15 Photo R.J. Marshall)

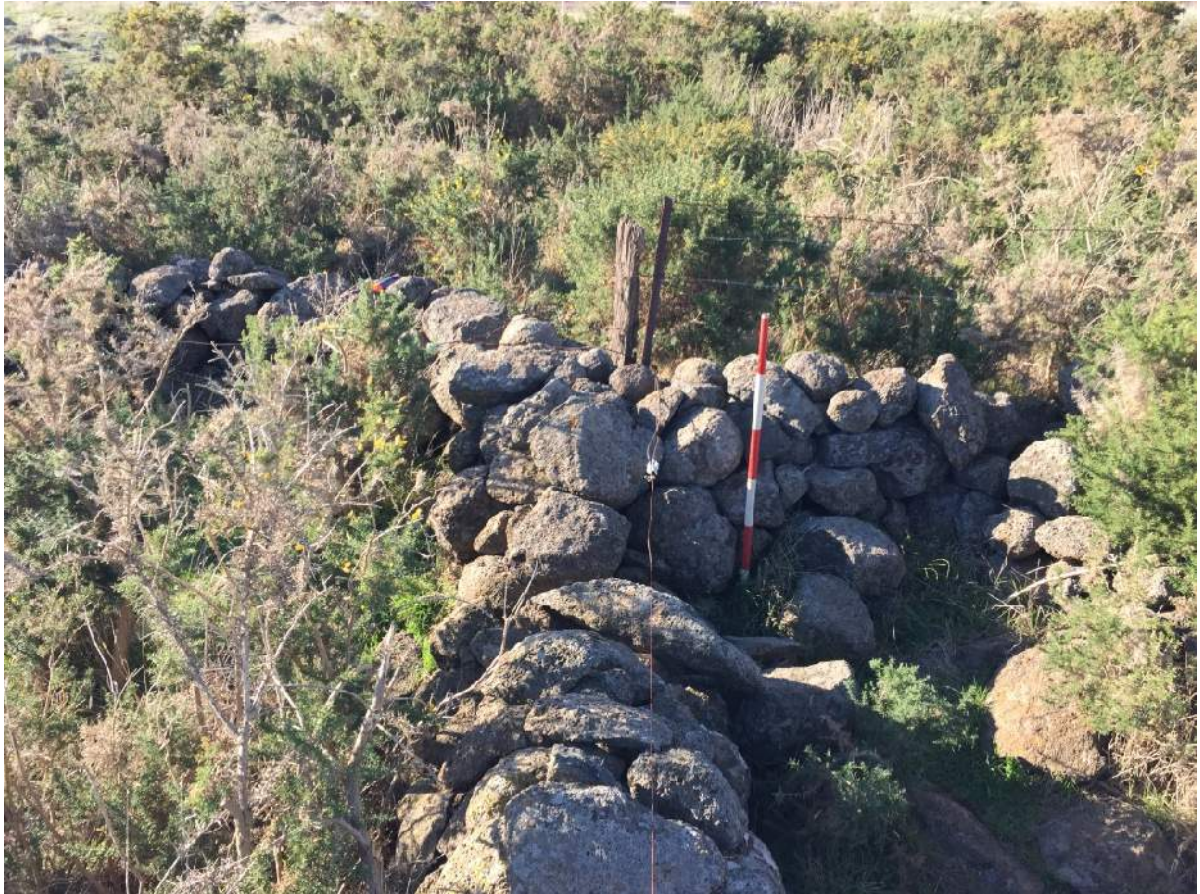
The intersection of Walls No 2 and 3 at 40 Dwyer Street Kalkallo looking east. The wall on the RHS is a low composite type that heads south and was not part of this current assessment. (27/5/15 Photo R.J. Marshall).

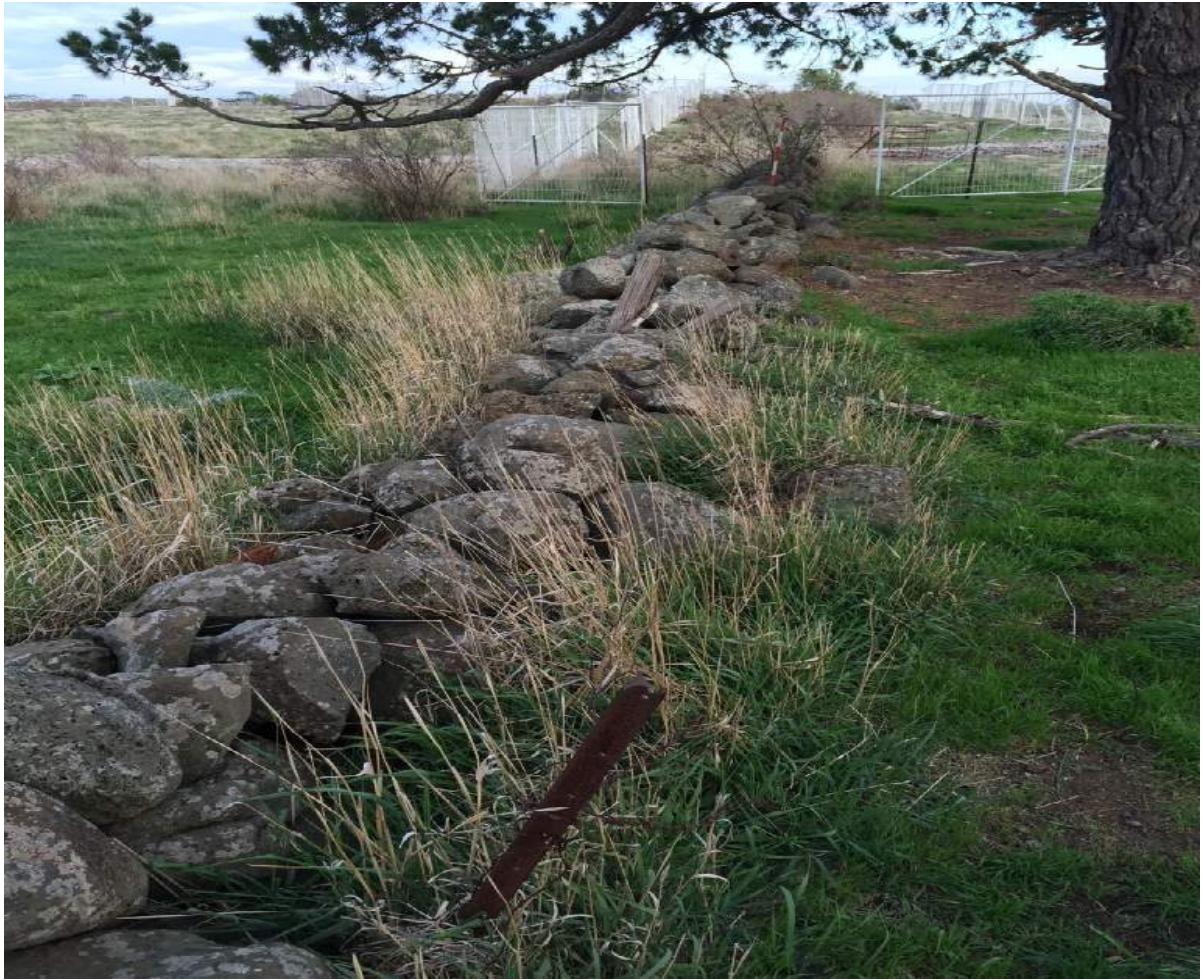
The eastern sections of Wall No 3 at 40 Dwyer Street Kalkallo looking west. This is a low composite wall and a remnant timber is visible mid frame (27/5/15 Photo R.J. Marshall)
